**Inspection Notice**  
MSA Latchways Web PFLs

April 29, 2019

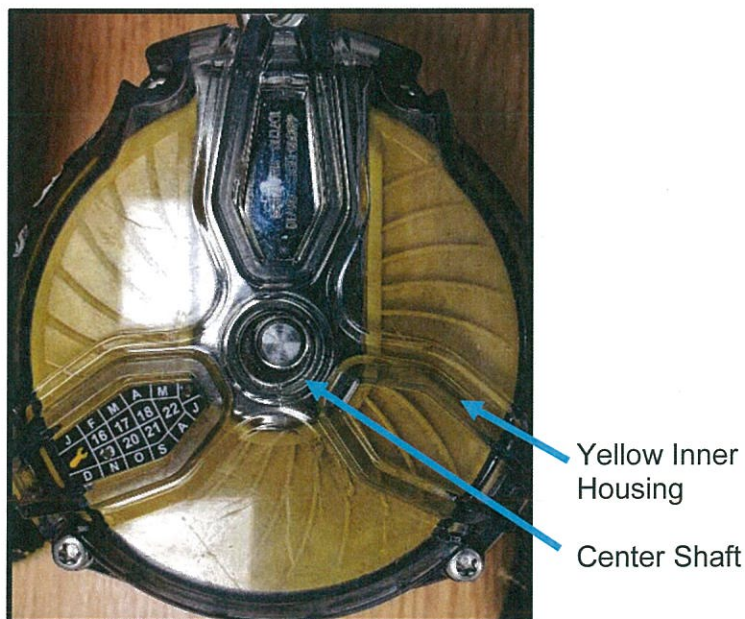
**Figure 1 – Unflared Center Shaft**

MSA is issuing this Inspection Notice to inform you that MSA has received a field report of an unflared center shaft in an MSA Latchways 10 ft. (3m) web PFL. **MSA has not received any reports of injuries associated with this condition. However, we are requesting that you perform the inspection outlined in this notice.**

If subjected to rough handling, an unflared center shaft may eventually dislodge completely from the web PFL. If the shaft dislodges completely from the web PFL, the web PFL will continue to pay out and retract during normal use, but will not arrest a fall.

- 1) Confirm that the web PFL has a yellow inner housing (see Figure 1). If your web PFL does not have a yellow inner housing, no further action is required.

**Inspect per the Instructions in this Notice. Remove from service any web PFL that does not pass the inspection.**

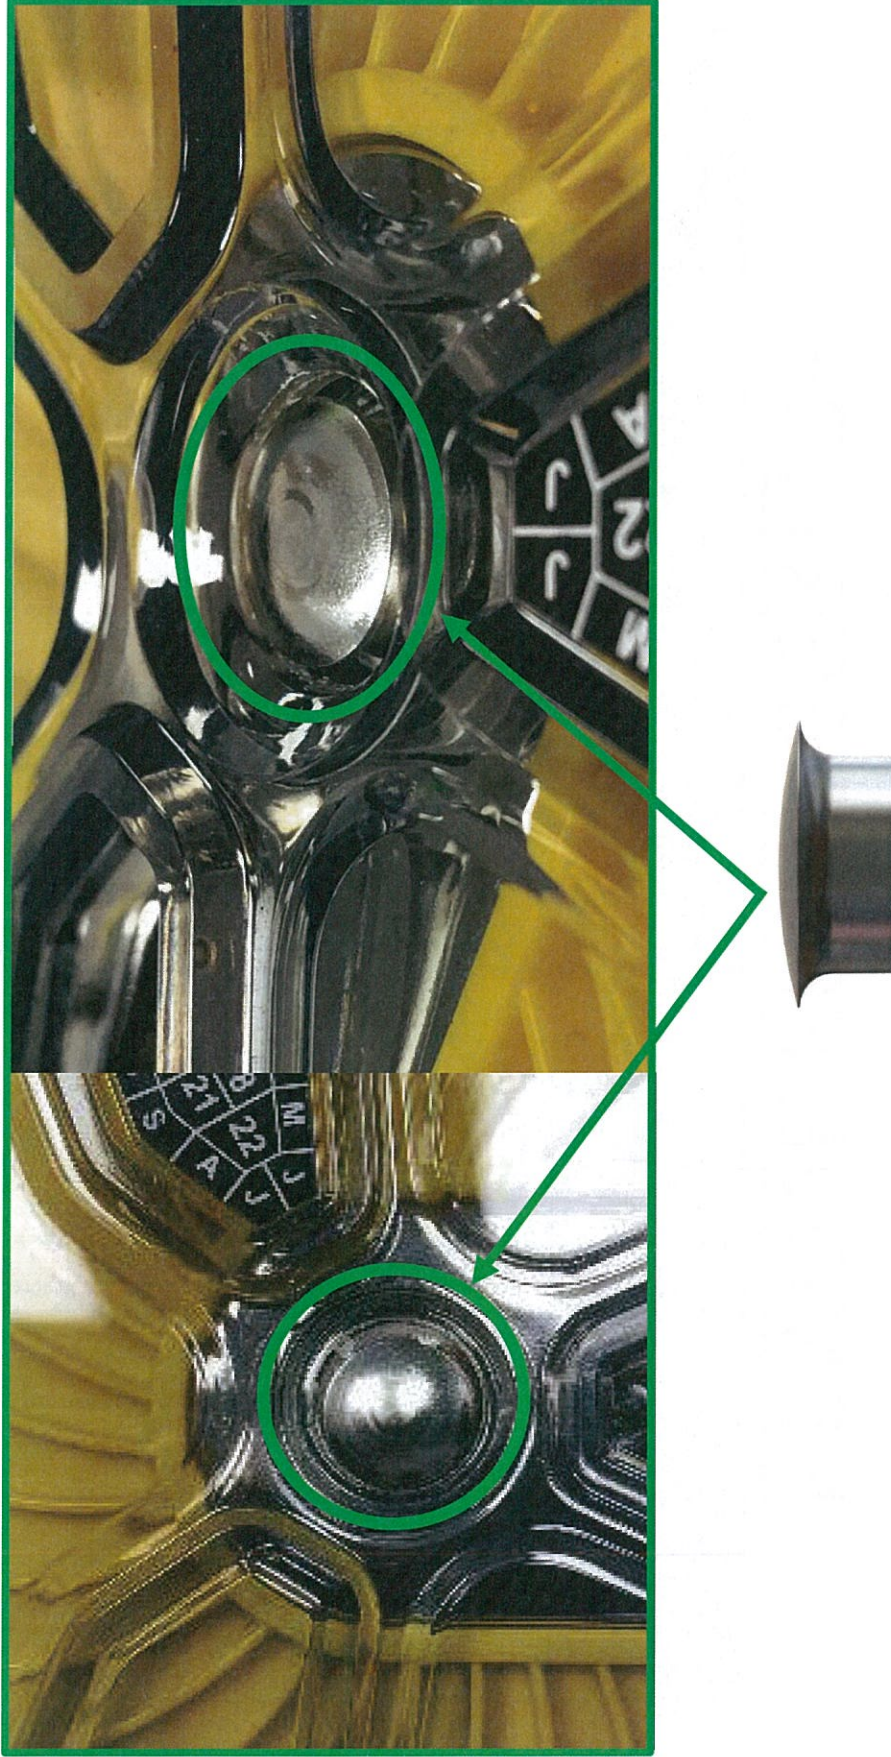
Figure 2 – Flared Shaft End

- 2) Inspect the shaft end that is on the same side of the PFL as the yellow inner housing.
  - a. Visually inspect the shaft for a flared end, as shown in Figure 2. If the shaft has an unflared end, as shown in Figure 3, **remove the PFL from service** and follow the steps in the "Replacing Affected PFLs" section.

## Perform Inspection Step 2b to Confirm Acceptable

- b. If the PFL is not removed from service in step 2a, perform the following confirmatory test for an unflared end. With no load on the PFL lifeline and while holding the PFL in your hand, push on the end of the shaft on the yellow inner housing side of the PFL as if pushing the shaft out of the hole in the PFL. Some small axial movement of the shaft is normal. If the shaft can be pushed into the PFL and pulled out the other side, **remove the PFL from service** and follow the steps in the "Replacing Affected PFLs" section.

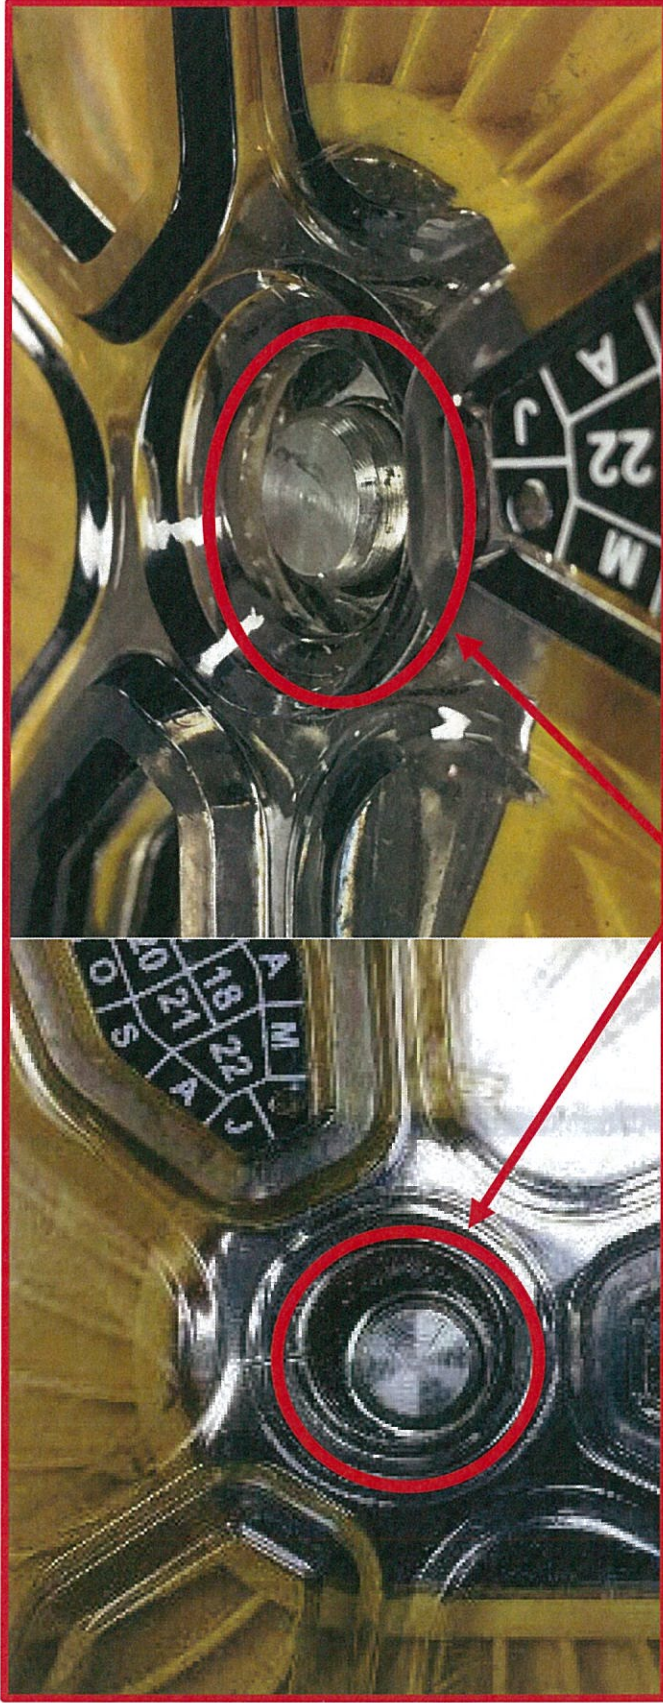
Figure 3 – Unflared Shaft End

# REMOVE FROM SERVICE

If you are in possession of web PFLs that have an unflared center shaft, we will provide you with replacements free of charge.

To receive a replacement, please complete the enclosed *MSA Latchways Web PFL Return/Replacement Form* and e-mail it to MSA Customer Service at the appropriate e-mail address below. Replacement PFLs will be shipped to you and we will forward you instructions for returning the affected PFLs.
