IMMEDIATE STOP USE AND INSPECT NOTICE

No. G-S009-A

This notice is intended to communicate immediate stop use and inspect information regarding a small selection of Guardian Diablo 2.5 Cable Self-Retracting Lifelines (SRLs). An isolated manufacturing issue that could result in serious injury or death has been identified and requires immediate inspection.

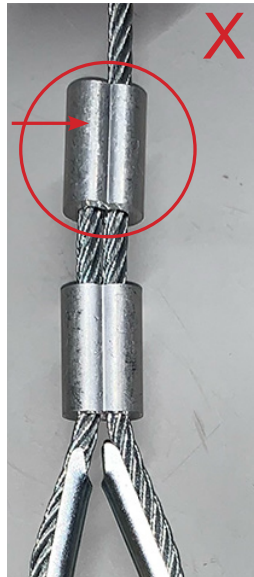
Example of compression sleeve without vertical or horizontal clamp marks.

Step 2. Verify that both compression sleeves have been compressed by visually inspecting for either vertical or horizontal clamp marks as shown in Figure B. If clamp marks are not present, proceed to Step 3.

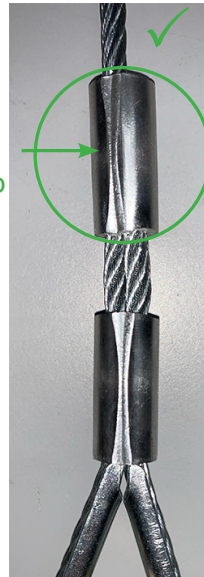
Example of compression sleeve with vertical clamp marks.
